UNITED STATES ENVIRONMENTAL PROTECTION AGENCY
REGION IX – PACIFIC SOUTHWEST REGION
75 Hawthorne Street
San Francisco, CA 94105-3901

Re: Clean Water Act Pretreatment Inspection

**Region 9 Enforcement Division
75 Hawthorne Street
San Francisco, CA 94105
INSPECTION REPORT**

Inspection Date(s):	8/15/2018	Inspection Announced: No	
Time:	Entry: 10:47 a.m.	Exit: 2:35 p.m.	
Media:	Water		
Regulatory Program(s)	NPDES – Industrial Pretreatment Program		
Company Name:	Pacific Choice Seafood		
Facility Name:	Pacific Choice Seafood		
Facility/Site Physical Location:	1 Commercial Street		
(city, state, zip code)	Eureka, CA 95501		
Geographic Coordinates (latitude, longitude):	40.804615, -124.174840		
Facility/Site Contact:	David Bodiroga	Maintenance Manager	
	dbodiroga@pacseafood.com		
	707-442-2981 ext. 8514		
Industrial User Permit No:	37		
Publicly Owned Treatment Works (POTW):	City of Eureka (City)		
POTW Permit Nos.:	Elk River Wastewater Treatment Plant (CA0024449)		
Facility/Site Personnel Participating in Inspection:			
David Bodiroga	Pacific Choice Seafood	Maintenance Manager	707-442-2981 ext. 8514
Inspector(s):			
Sirese Jacobson (Lead Inspector and Report Author)	Signature:

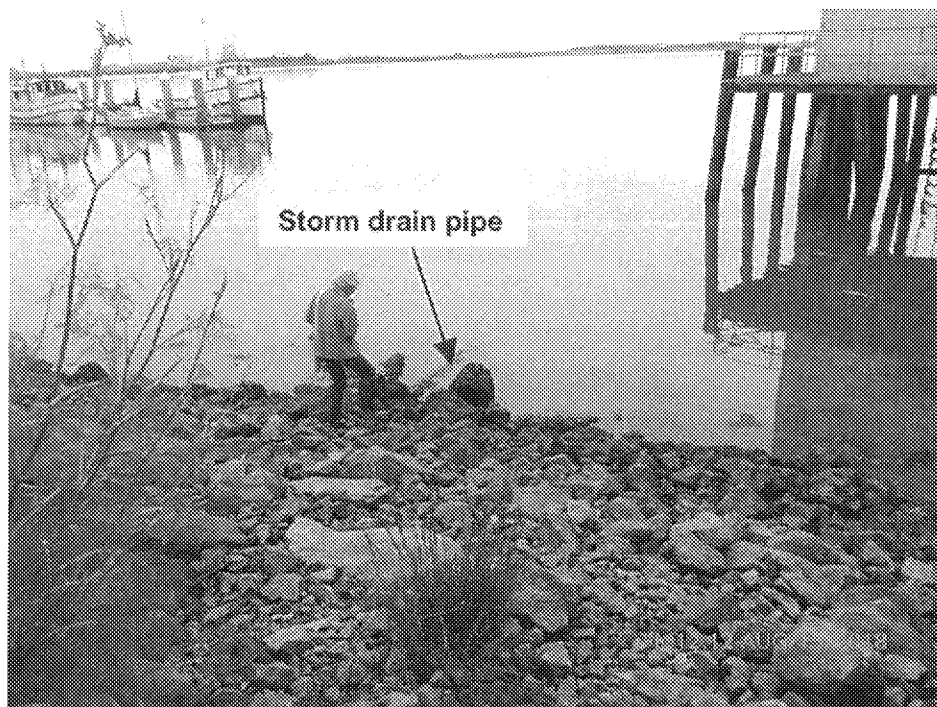
Photograph 13. View of the outlet from the storm drain shown in Photographs 10 and 11.
